## **Skibo A Canadian Forestry Camp**

**Results of a survey undertaken by NoSAS and ARCH 2014—2015**

**Anne Coombs and Susan Kruse**

**August 2021**

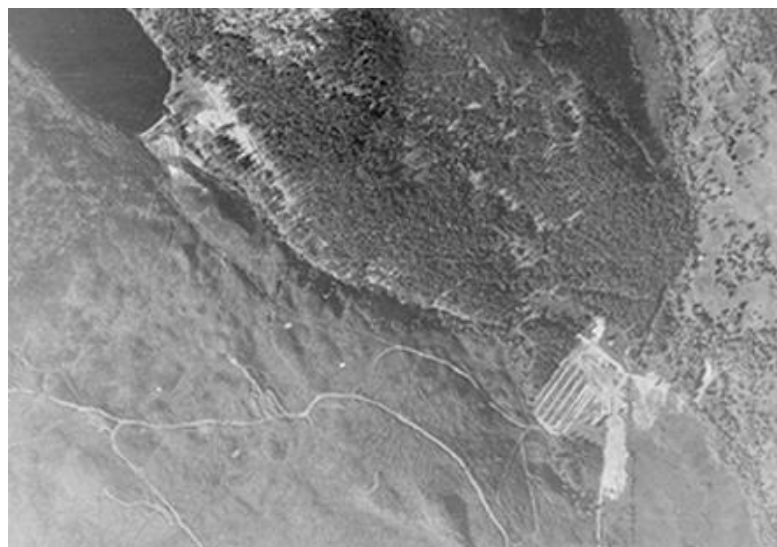
Figure 6 Aerial photograph taken 1946  
 Image: NCAP / [ncap.org.uk](http://ncap.org.uk)

This conclusion is backed by the aerial photograph taken within a few years of the end of the Second World War and clearly shows the tracks of the wagon ways and large areas of sawdust (Fig 6).

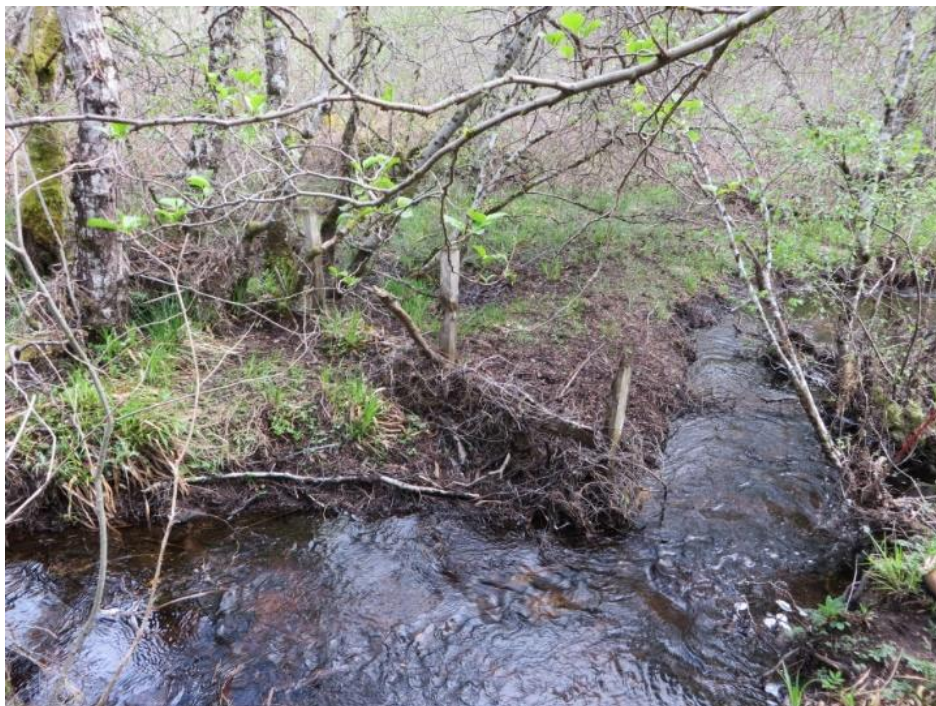
*Figure 7 View of remains of possible sluice.*

1	266189	890829	The remains of a possible sluice. A fence post and wooden structure partially across the burn.
2	266162	890816	A dip in the track indicating the position of the lade carrying water into the pond. A shallow channel is visible on both sides of the track.
3	266198	890806	Bridge across the now dry channel of the burn which has been redirected to E. The remains of the bridge are 4 timbers with some bolts.
4	266188	890790	The outflow channel from the pond.
5	266163	890758	Gps taken at N end of wagonway base. The base is made of fine gravel and is c.3m wide. There are no sleepers or rails on the base but shallow depressions show where the sleepers would have been.

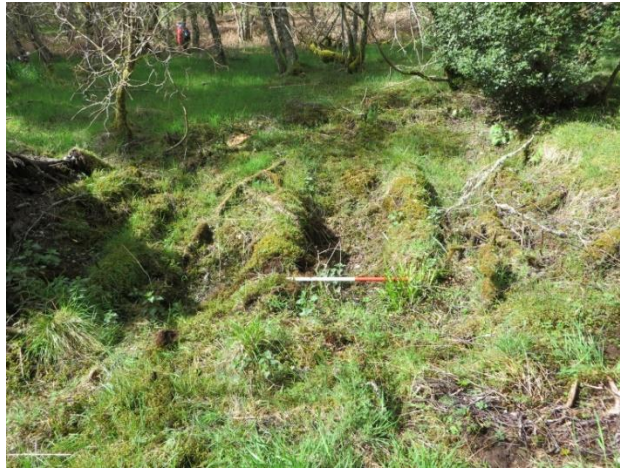
The Spinningdale Burn has been utilised for water power since the late 18th century. The burn has sections which have been straightened and some of the tributary burns are also unusually straight suggesting management of the water sources. There is a small tributary of the Spinningdale Burn just to the north of the modern Path A. It has been rerouted and now crosses below this track in a modern culvert immediately to the east of the junction with secondary Path B. On the north side of Path A there are the vestiges of a wooden barrier which would have formed a dam or sluice (NH 66189 90829) to divert the water back into a water channel or lade to run across Path A (NH 66179 90643) into a lade leading to the pond on the south side of Path A. There is a similar lade leading out of the pond where the water would have run back into the tributary and thence into Spinningdale Burn. The tributary ran to the west of Path B during the Second World War and was crossed by a wooden bridge; the remains are shown in Figure 8.

*Figure 8 View of remains of bridge over old route of burn.*

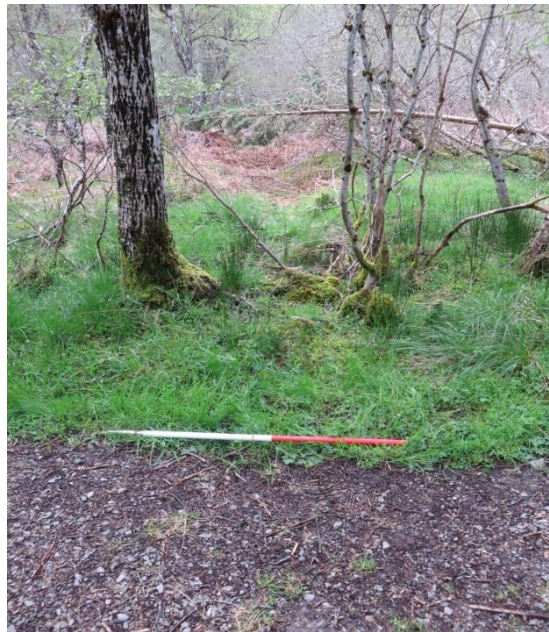
*Figure 9 View of dip in Path A and lade to south.*

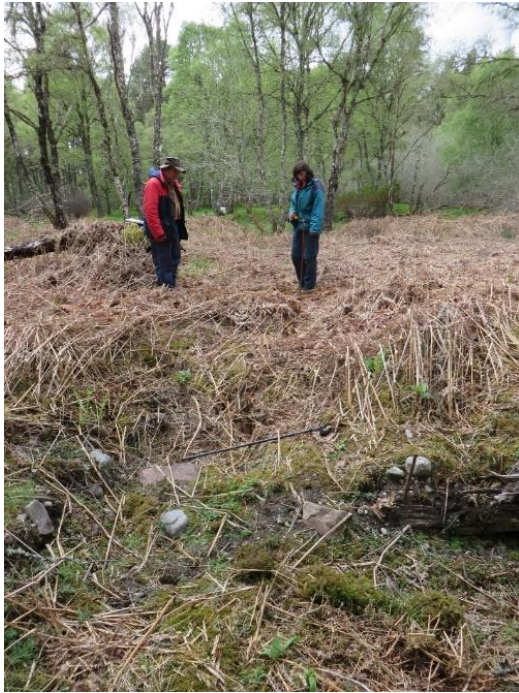
A shallow pond was found (NH 66177 90789). Its exact dimensions are difficult to make out as it is filled with vegetation, but it is approximately 10m north south by 15m. On the west side there is a clear edge with a timber revetment. The lade from the burn enters the pond on the north east corner. Beyond the west edge there is an unattached timber (NH 66177 90789) with bolts like a bolt found in a timber forming the bridge. The ground slopes at the south west part of the pond, forming a ramp where the newly cut and washed logs would have been hauled up towards the sawmill. The timber found beyond the pond may well have been part of a structure which dragged the logs out of the pond. At the south east corner of the pond the outflow lade leads to the old route of the tributary. The pictures of similar sawmill operations show the logs were washed prior to being cut in the sawmill to limit the damage to the saw blades. Figures 10 and 11 show the pond and structural timber at present and Figures 12 and 13 are black and white photos showing a similar washing pond in use elsewhere.

Figure 10 View of pond with timber revetment and west ramp.

21	266177	890789	The pond c.10m N-S by 15m E-W.
22	266117	890783	The 2 banks with hollow between. A possible loading bay.
23	265452	890560	Septic tank
24	265444	890592	Wooden board on pine tree, part of communication system.
25	265331	890602	E end of accommodation platform
26	265307	890594	Septic tank

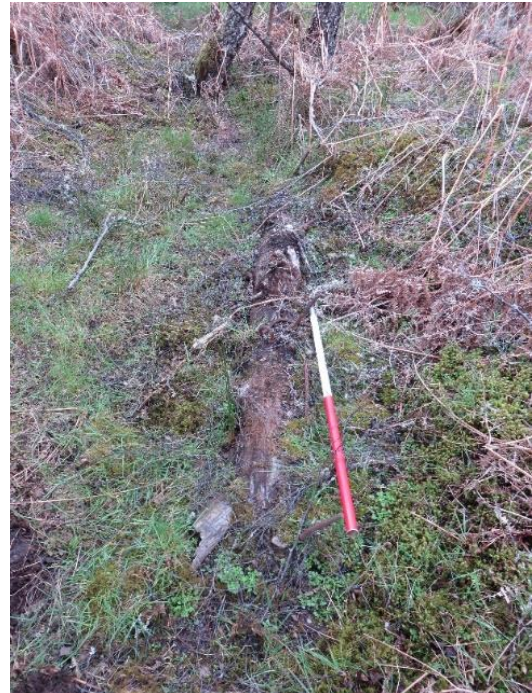
Figure 11 View of single timber beside pond.

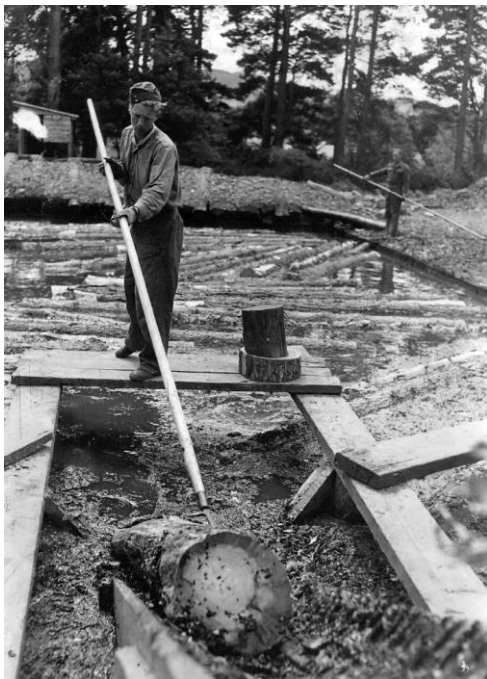
Figure 12 (left) Logs being taken out of a washing pond, Inverness-shire or Black Isle. (©YMCA, reproduced on HistoryLinks Archive <https://www.historylinksarchive.org.uk/picture/number3004> accessed December 2020)

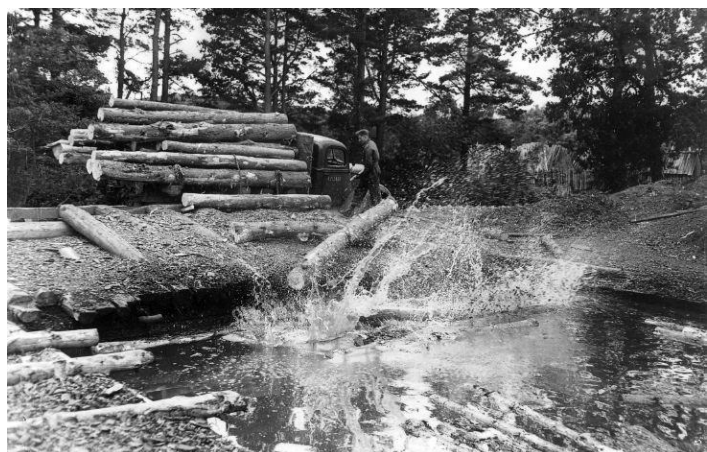
Figure 13 (right) Logs being tipped into a washing pond, Inverness-shire or Black Isle. (©YMCA, reproduced on HistoryLinks Archive <https://www.historylinksarchive.org.uk/picture/number3012> accessed December 2020)

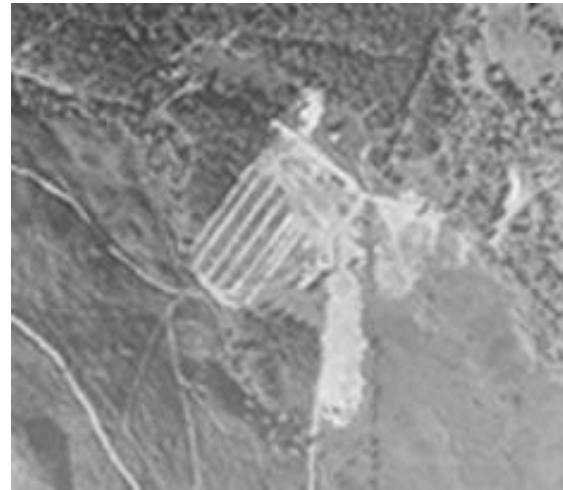
Figure 14 Close up of post Second World War aerial photograph showing sawmill area with wagonways. Image: NCAP / [ncap.org.uk](http://ncap.org.uk)

On the aerial photograph taken soon after the end of the Second World War (Fig 14) there are distinct white areas to the north of Path A and to the east of Path B beside the sawmill area; these are sawdust piles. Elsewhere on the aerial photo some of the white areas are simply cleared ground for example the accommodation area near Loch Migdale (Fig 6 and Fig 28). There is no evidence of sawdust piles surviving on the ground. But where did the sawdust go? It is too large an area to have rotted down without leaving some change in the topography. It is possible that some of it was removed and possibly reused, although there does not seem to be any local knowledge of this happening. At present the area where the sawdust would have been piled is much less boggy than the surrounding ground and it is possible that the piles were spread and have since rotted down to form a dryer area and this can be seen as different vegetation.

There are six wagonways which conform to the 1946 aerial photograph, though grass now obscures some detail. The wagonways shown on the plan are grid referenced in the list of features at the end of the document.

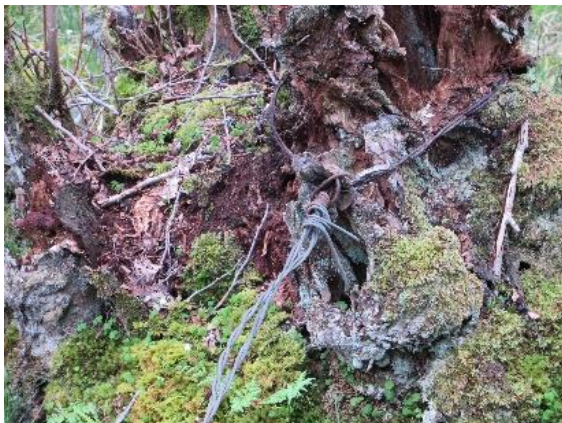
Figure 15 View of wire attached to tree on south side of burn.

At the side of the Spinningdale Burn, the curve of the wagonway shown on the aerial photo is still visible on the ground. Also, on the aerial photo there are informal tracks running down the hill to the left of the photo towards Spinningdale Burn. At present directly opposite the indistinct remains of the track there is a single strand of wire attached to a tree on the south side of the burn and secured under a boulder on the north side. This is likely to have been associated with some form of crossing, possibly for carrying logs to the wagonway.

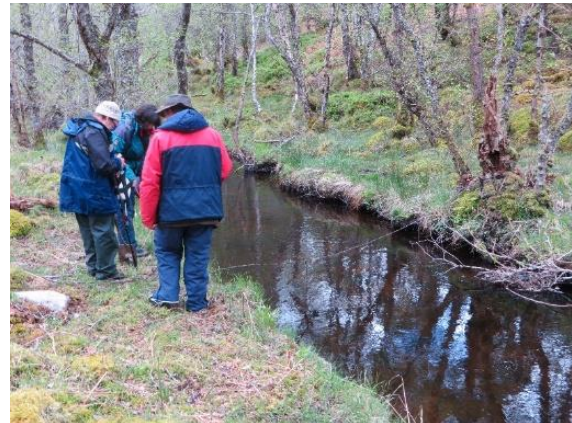
Figure 16 View of wire across burn.

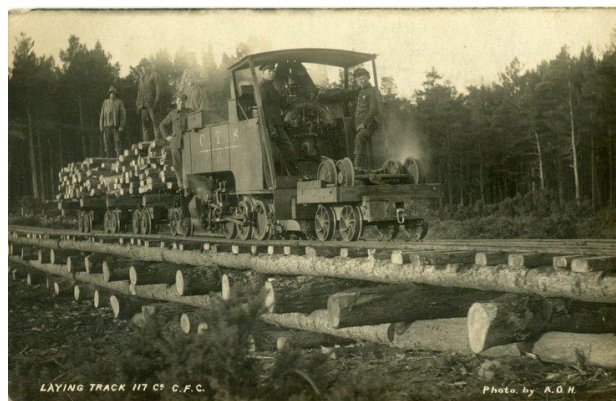
Figure 17 Logs on wagon (reproduced with permission from Historylinks Archive [www.historylinksarchive.org.uk/picture/number12478](http://www.historylinksarchive.org.uk/picture/number12478))

There are photographs on the Internet showing the logs being pulled off the wagons at other camps, and the men are standing in a hollow. The photo may be showing a feature similar to the three hollows or pits found at the west end of the site. NH 66109 90756

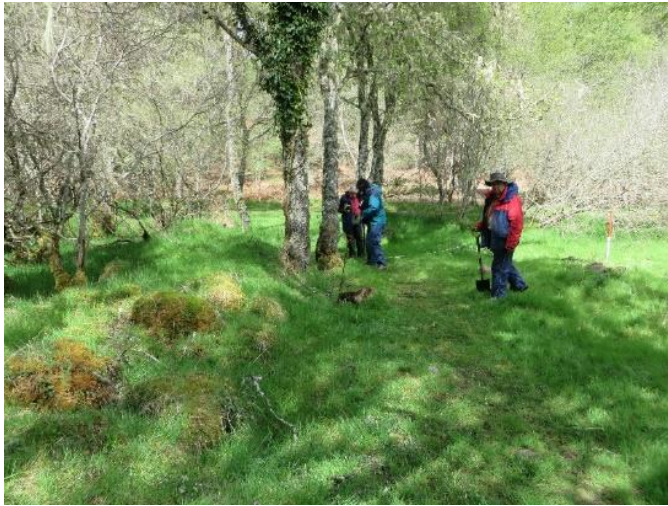
*Figure 18 View of eastern wagonway.*

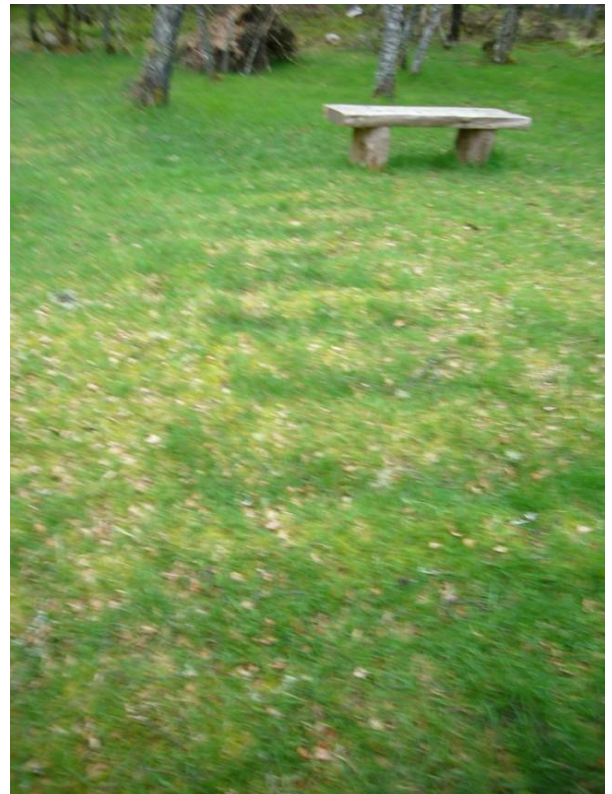
During the survey a small section of one of the wagonways was cleared of vegetation and revealed a base of fine gravel with regular hollows which would have had timber sleepers for the metal rails to sit on. A bolt or fastening was found on the gravel. The hollows can be seen clearly when the vegetation is low in the winter. Between many of the lines of tracks there are boulders, perhaps cleared when constructing the tracks.

*Figure 20 View of wagonway, with darker grass indicating sleeper positions*

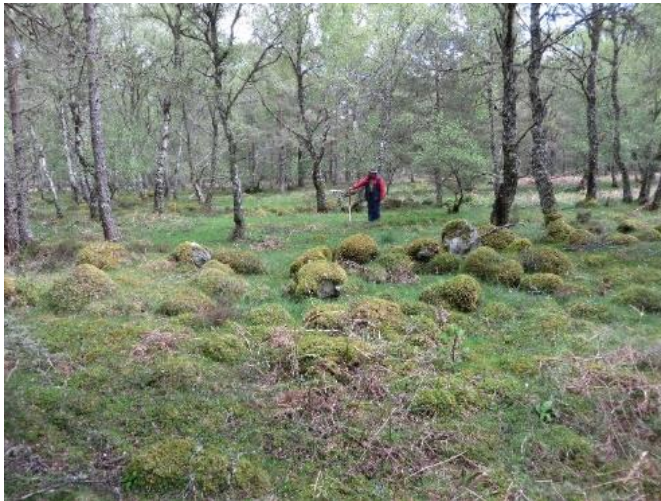
*Figure 19 View of stone piles between wagonways.*

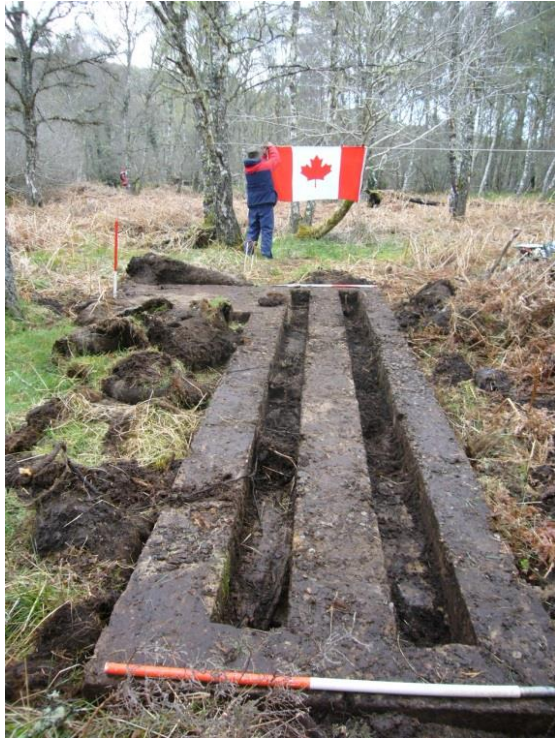
To the east of the possible loading bay at NH 66148 90785 is a thick concrete foundation base oriented east-west, which has channels within the base. Whatever was placed here would have been heavy to require such substantial foundations. It seems very likely that the sawmill would have been on such a base with the channels, which are full of nails and rotted timber would have secured the sawmill in place.

Figure 21 View of base of sawmill.

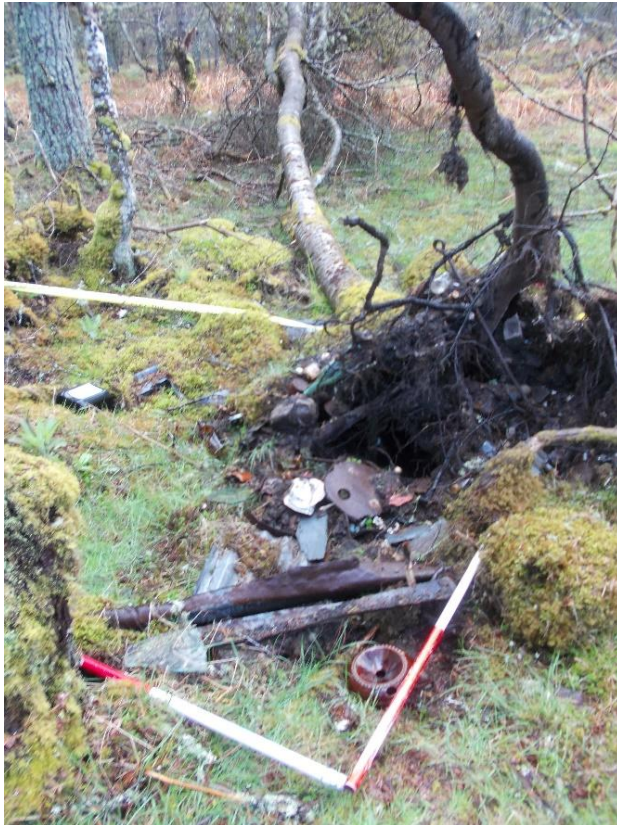
Next to one of the wagonways were the remains of the midden which was cleaned out during the survey to remove the rusting metal and broken glass. The complete bottles and metalwork were photographed as was a spittoon. Some of the bottles and possibly the spittoon were contemporary with the occupation of the sawmill site. Some of the midden was relatively modern. There was a second midden containing wire and metal to the north of Path A. This midden was not cleared as it was not easy to access.

Figure 24 View of midden prior to removal.

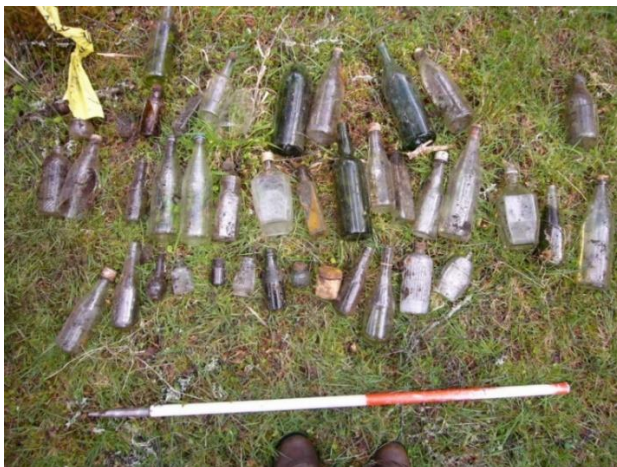
Figure 26 View of bottles from midden.

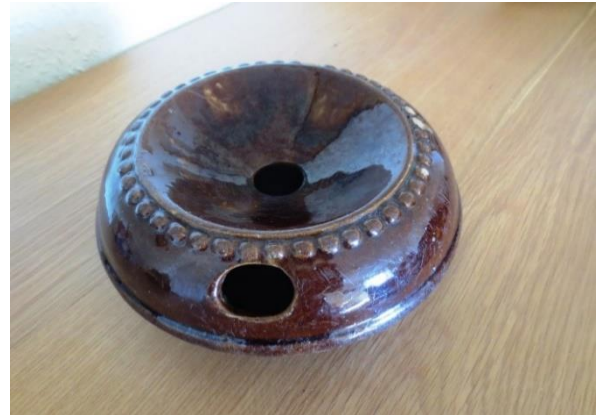
Figure 25 View of spittoon

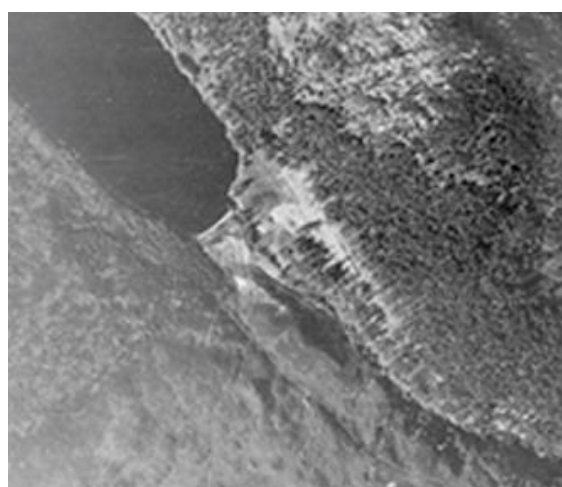
*Figure 18 Close up of aerial photograph post Second World War showing east end of Loch Migdale with cleared areas where the accommodation huts would have been. Image: NCAP / [ncap.org.uk](http://ncap.org.uk)*

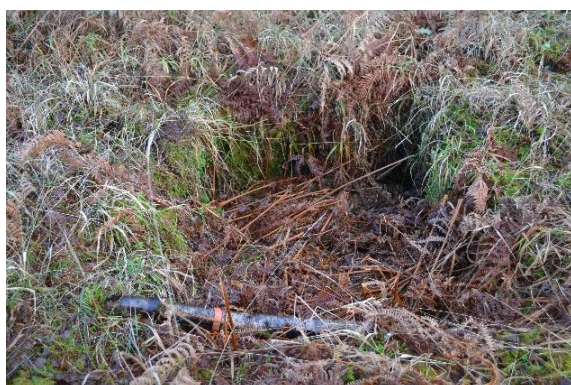
*Figure 29 Midden associated with long accommodation platform*

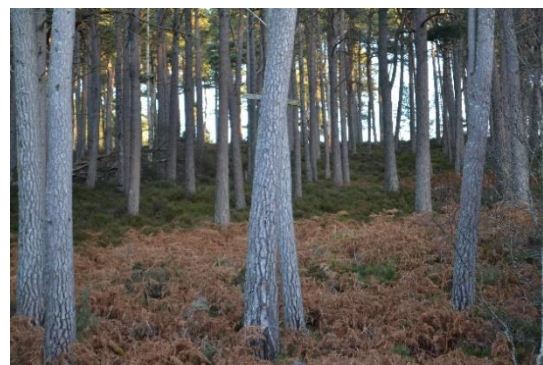
On the north side of the platform is the only surviving sign of the telephone system which would have provided communications between the sawmill area and the accommodation area. There is a plank of wood nailed to a Scots pine c.4m above the ground (NH 65444 90592).

*Figure 30 Plank of wood on Scots pine, part of communication system.*

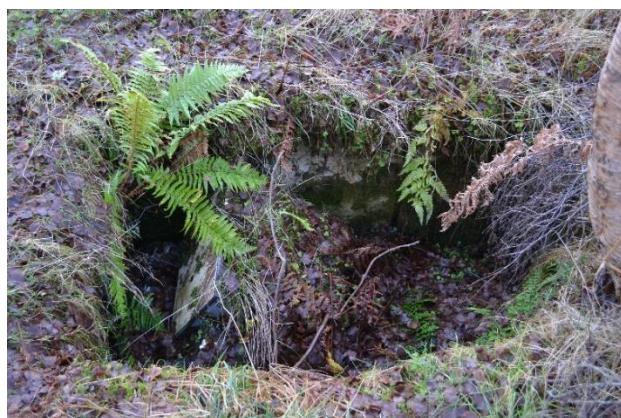
When probed there is gravel below the present vegetation. The length of the platform is c. 150m east-west and c.12m north-south which would allow several wooden buildings to be sited along the platform. On the south side of the path there is a concrete lined pit 1.5m by 1m set into the ground (NH 65452 90560). This has been interpreted as a septic tank.

*Figure 31 (left)Septic tank opposite accommodation platform beside Loch Migdale*

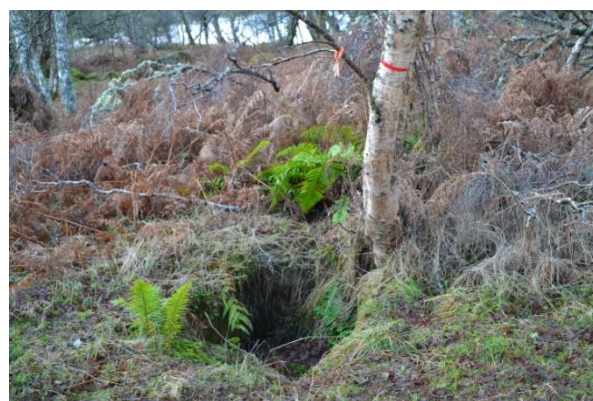
*Figure 32 (right) Septic tank opposite accommodation platform beside Loch Migdale*
