Evanton Wartime Remains: sites and features

During the first half of 2013 a group gathered at the Cornerstone Cafe on Wednesday evenings to remember and research the wartime remains in Evanton – buildings, sites, or monuments which were new, modified or no longer there. Using old maps, photographs (some over 90 years old), aerial photographs from the wartime and later, military archives and plans, memories spanning over 70 years and details gleaned by walking over the area, information about over 160 sites was gathered. Some pupils from the Kiltearn Primary school, Inverness Young Archaeologists Club and Dingwall Academy joined us as well, recording remains and learning about the wartime and later activities in Evanton.

This report summarises the results of this research. Most of the recorded sites relate to wartime remains, but a few other unrecorded sites were also noted. The details and more photos will also be forwarded to the Highland Council Historic Environment Record (HER) (<http://her.highland.gov.uk>), the RCAHMS Canmore database (<http://www.rcahms.gov.uk/canmore.html>), and the SCAPE/SCH@RP coastal sites at risk database (<http://scharp.co.uk/>) where they will provid

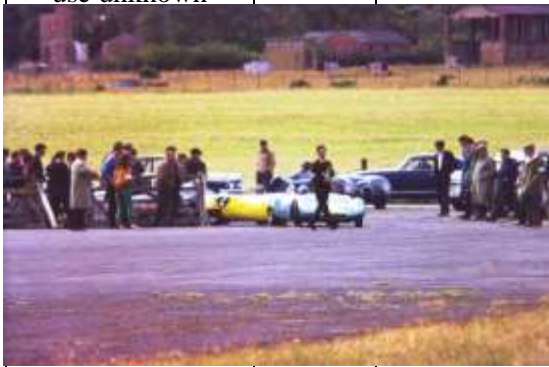
8	Various buildings, use unknown		Unknown	<p>The Highland Car Club met on Evanton airfield in the 1960's. Large crowds attended, and pictures survive of some of the events. One photo in particular shows some of the wartime buildings which no longer survive. One is quite tall and distinctive. The exact position of these buildings and their functions remains a matter of debate. The picture was perhaps taken at the east end of the runway near the gas works. Further investigation is needed to pinpoint these buildings.</p>			<p>Eddie Szymborski, Willie Fraser, Alan Kinghorn Alasdair Cameron + discussion</p> <p>Photo: Alasdair Cameron</p>	
---	--------------------------------	--	---------	---	--	--	--	--

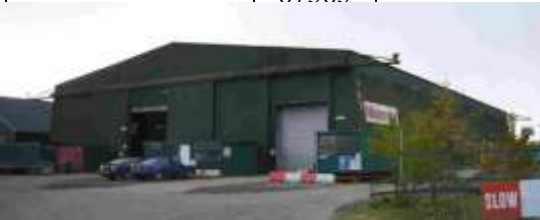
12	Hangar

NH 62623 67565	Surviving	Pentad type hangar in B camp, now used by Munro's for recycling. Post war, the hangar has had a number of companies use it, including a box factory, Duncan Munro timber, a firm putting pylons in the Fyrish area, then assembling cells for the Invergordon smelter, James Jack, Haulage & Cranes and Norfrost. On the 1943/44 plan, this is marked Bldg No 70A "Major Inspections, Minor Repair and Modifications", 1 of 2 "Large hangars, each with hutting 85' x 16' dispersed. (Coke stove heating)" (NA ADM 1-13568). Aerial photographs from 1944 and 1946 show clearly that this was the last hangar to be built in this area, constructed after the 1944 flight.	MHG27882	119764	Willie Fraser, Eddie Szymborski, Alan Kinghorn, Bill Shirren Photo: Susan Kruse	1

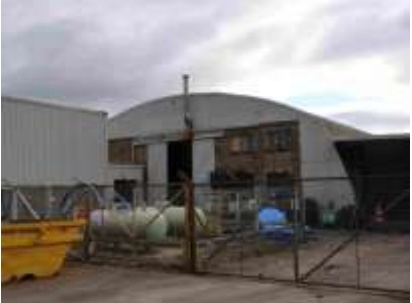
Arch No.	What is it?	Where is it?	Condition	Description and Comments	HER	Canmore	Contributors	area
22	Two Hangars	NH 62759 67630; NH 62794 67644	1 gone, 1 surviving	Two Mainhill hangars/sheds were built in the 1943/1944 expansion of the airfield on Beechwood Road. The shed to the west listed on the wartime plans was destroyed after the war, and replaced by the new building. In the late 60s and early 70s, it was the Shattaline company where ornaments were made out of resin, in a process which shattered them internally, not on the outside. All sorts of items were made, including a plastic grave cross prototype. It was described by workers as an unpleasant place to work. There is a website describing the history and work. Shattaline went in to liquidation 1972/3. The shed to the east was taken over by Mackay and Macleod, then Shanks and McEwen and now Isleburn. On wartime plans, it is listed as electrical, instrument, auto-pilots and camera repair shop, "Small hangar (60 x 84 - steam heating) in dispersal area, with hutting 30' x 16'." (NA ADM 1-13568).			Bill Shirran Alasdair Cameron Eddie Szymborski, Alex Fraser, Bill Shirran, Alpin MacDonald Photo: Preston White	1

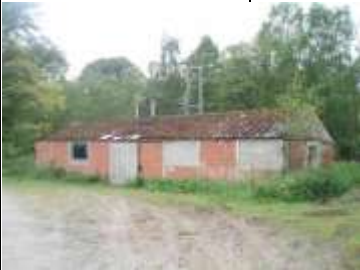
NH 62052 67566	one building surviving	The old Novar estate sawmill was situated here post war to 1990s. The sawmill utilised wartime buildings and there is one concrete portal framed hut still left. The hollow block wall was lined with bricks. Foundations to the southwest suggest that it might have been larger. Foundations of other buildings can also be discerned in the area, including one with a pit 1.5m deep, presumably for motor servicing. Other buildings depicted on plans and aerial photos are no longer visible, but foundations may survive under vegetation. Plans suggest that these buildings were stores in wartime. Near the old A9 at NH 62107 67512 is a dump of concrete wartime frames, probably from air raid shelters.			Alpin MacDonald, Ian Midgley, Alan Kinghorn, Bill Shirran, Roddie Lovett Photo: Alan Kinghorn	2

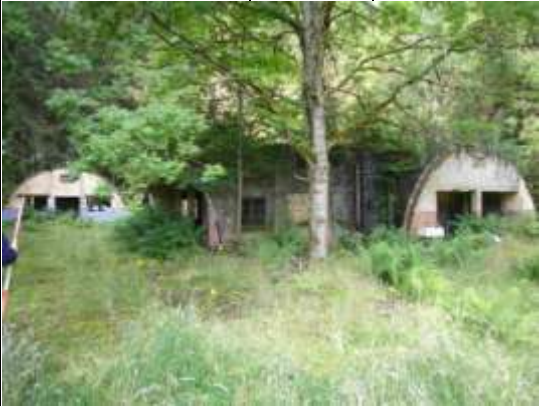
Arch No.	What is it?	Where is it?	Condition	Description and Comments	HER	Canmore	Contributors	area
147	Military Buildings	NH 62535	Surviving

<p>A large complex of buildings, comprising a high brick building with large doorways and with abutting nissen-type structures to the south and northeast, survives in a ruinous condition to the east of the sawmill. Only one end of each of the abutting nissen-type huts survive. The two-storey large building is well ventilated, with chimneys, louvers and holes, and has a concrete slab roof. There is tiling on some of the floor of the main building, and the walls retain wartime paint. The northern nissen hut had a black flooring lying on the concrete foundation. This complex of buildings is on wartime plans, but unfortunately not annotated. Nearby to the northwest is a now-demolished canteen, so it is unlikely to have been used for this purpose. Perhaps it was an officer's mess, but the large ceilings and wide doors are puzzling.</p>			Photo: Susan Kruse	2

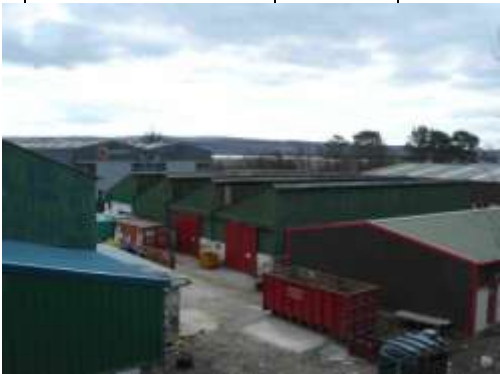
NH 62550 67206	surviving	The current Blythswood retail outlet has a distinctive shape, allowing high north facing windows to give even lighting conditions indoors. It is a steel and brick building with roof timber sarking and probably felt on top. According to wartime plans, it was used at the end of the war for an airframe component repair shop, blacksmiths, coppersmiths, metal works and welders shop (NA ADM 1-13568). In a RAF plan from 1946, the building is not labelled by function, and is said to be part of Naval buildings on the site. It appears on the 1946 aerial photograph with camouflage paint on its roof. Innes 1995 p. 28 shows a similar type of building from Arbroath which were aircraft repair shops of a naval type. After the war, the building was used at some point as a potato store.			Alasdair Cameron, Eddie Szymborski, Roddie Lovett Innes, Graham Buchan 1995. British Airfield Buildings of the Second World War (Aviation Pocket Guide 1) Archie Rose (via Alasdair Cameron) Photo: Alasdair Cameron	3

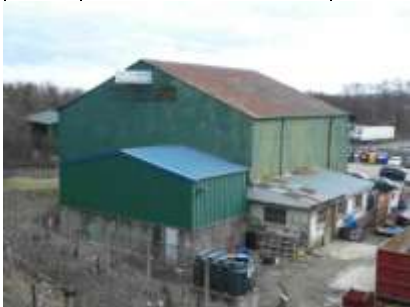
36	Modified workshop	NH 62597 67194	Surviving	<p>The base of this small hangar/shed appears to be of wartime date, but the building has been heightened, probably after the war. According to wartime plans it was used for propellers, hydraulics, oleo wheels and tyre repair workshop (NA ADM 1-13568). The plan also shows a now-demolished air raid shelter to the west, and a series of small huts to the east, only surviving now in their foundations.</p>			Photo: Susan Kruse	3

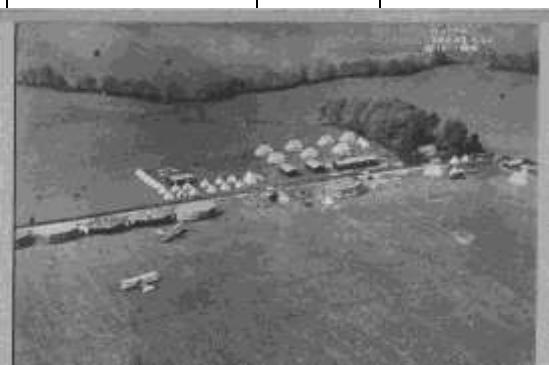
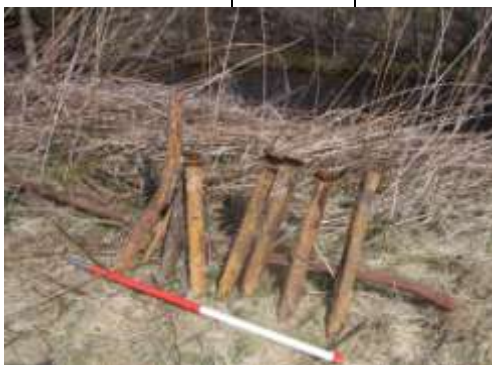
AREA 4: Site of the Original Airfield								
1	Newton of Novar airfield (also known as Novar airfield)	NH 625 670	Pre WWII remains destroyed.	<p>The airfield buildings were located on the Industrial estate, across the current Big Burn, under and in the fields around MacGas. The camp is first mentioned in the Ross-shire Journal in 1922 (16 June). It was used seasonally twice a year to service the planes when the fleet was in Invergordon, with accommodation in tents and makeshift timber huts. The airfield was upgraded and massively expanded beginning 1937.</p> <p>Nothing remains from this early airfield. Fortunately photos survive of the airfield, some at Alness Heritage Centre, some on the Invergordon Archive website, at Cornerstone Cafe in Evanton and in Jim Hughes' books, <i>Airfield Focus 16: Evanton</i> (1994) and <i>A Steep Turn to the Stars</i> (1991). The photographs show tents and canvas and timber Bessonneau hangars. In the grass near the burn large metal stakes (pickets) have been discarded, and perhaps are remains of large tent pegs for these canvas tents.</p> <p>The road can clearly be seen in the photographs, and survives today, providing a good frame of reference. It is paralleled by a channel known locally as the mill stream, presumably connecting from the mill at Newton Road North, but culverted in a number of places. This mill stream now joins to the Big Burn, but the burn has been diverted to its present course some time after the war, probably between 1962 and 1965 judging from aerial photos. Before then it took a route towards the present Blythwood premises. The mill stream took a sharp turn to the south near the copse so visible in the photos.</p>			<p>Alan Kinghorn Eddie Szymborski Willie Fraser</p> <p>Photo: Camp in the 1920s. Crown Copyright. Formerly in the possession of Mrs Dunnett.</p> <p>Photo of metal pickets: Susan Kruse</p>	4

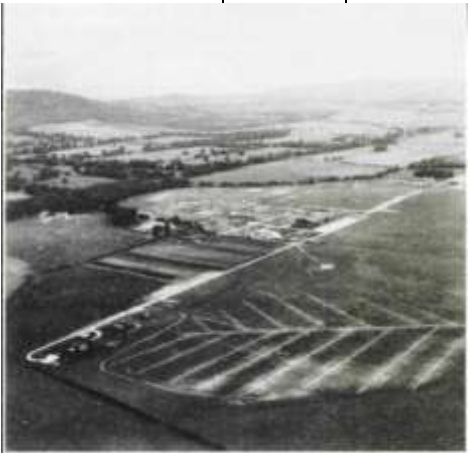
Arch No.	What is it?	Where is it?	Condition	Description and Comments	HER	Canmore	Contributors	area
100	Military Camp	Centred on NH 62526 67083

<p>The area of the original camp was upgraded in the late 1930s. On the original site of the pre WWII airfield, but to the north of the mill stream (see no. 1), there were a number of buildings including officers' quarters, mess rooms, offices, stores first aid post, workshops, motor transport, and a garage ambulance, built as part of the expansion of the airfield in the late 1930s. The road from the pre WWII camp was still maintained, and buildings were oriented on it. The mill stream beside it was culverted to the west, but open to the east. Three bridges over the mill stream survive, including a large one at NH 6254 6706 leading to the Parade Ground and a smaller one at NH 6259 67085, which does not appear on the plans, but may have been for vehicles which can be seen in a photograph from the late 1930s. Foundation remains can be felt by probing below the grass in places, especially in the area of the mess rooms. Many of the buildings in the pictures of the late 1930s are of timber and raised above the ground; not surprisingly, no traces remain of these. The Big Burn now marks the eastern edge of this, but photographs and aerial photographs clearly show that its present channel is a later redirected course, dating to the early 1960s. There is rubble from buildings on either side of the current course, and in one case, at NH 62464 67170 there are pipes in the embankment, suggesting this area was built on, as the 1946 plans suggest. A line of bricks from a building can also be seen at NH 62463 67153. The area to the northwest is a ploughed field, and this has destroyed remaining traces of buildings in this area. Traces of the road defining the edge of the camp in this area can, however, still be seen on google maps.</p>	MHG27885	119767	Aerial photo: courtesy Alness Heritage Centre. Photo of bridge: Susan Kruse	4

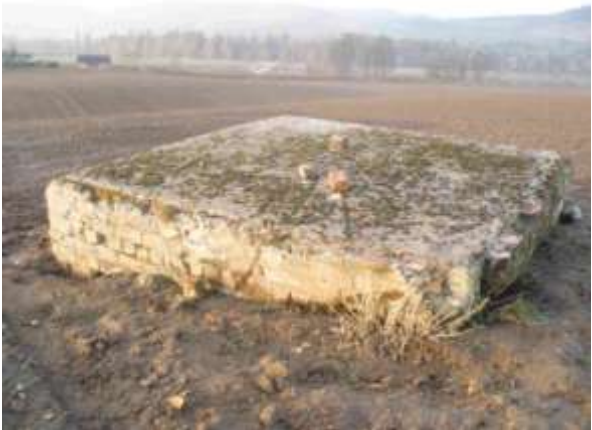
<p>A ruinous brick building now in a field on an elevated location overlooking the airfield, is remembered by some as a pillbox, and by some as a guardhouse. A report undertaken in 2002 thought it might be a gun emplacement or listening post (see HER record EHG1147). However, it is in the position where Battle Control is listed on a 1942 wartime map (NA AIR 29-594). It has a concrete roof, grooved radially, with nails around the perimeter, and a roof three bricks thick. It is almost square, c. 3.1 m by 3.05m. There are lintels underneath. It appears to have been dragged, though probably not far, and there are brick remains in the fields around (Brora and Hamilton can be identified). Alpin MacDonald remembers the structure as having a peaked roof. No one remembers a road leading to it. Eddie Szymborski remembers playing there as a boy. Roddie remembers that Ian Dunnett had the field during the war.</p> <p>On current evidence the best interpretation for the structure is either the remains of an unusually small Battle Control, or a pillbox to defend it.</p>			Alpin MacDonald, Roddie Lovett, Ian Midgley, Eddie Szymborski Photo: Alan Kinghorn	6

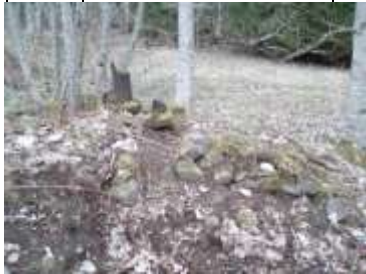
19	Water tower

NH 61870 67081	Ruinous	This was the main water tower for the camp. The tank was constructed of steel Braithwaite panels supported on a high open steelwork tower. The tower was cut down sometime after 1973. On the 1946 RAF plan, this is labelled Bldg No 5 "Water Tank Elevated 40' high" constructed "Steel Buildings", type 50,000 gal. Its square base appears clearly in the 1946 aerial photograph. The water tower was dismantled by Bob Dick, but the truncated legs still remain. The water came from Assynt in the Bog Hole area where there is a spring. In the woods above, there are large pipes from near the pillbox at NH61919 67246 and near the perimeter fencing above the air raid shelter at NH 61919 67097. Local tradition is that these were for the water tower, but it is unclear why they are situated where they are if this was the case; moreover, they are to the north of the mill stream, though this too may have been redirected after the war.			Alpin MacDonald, Eddie Szymborski, Bill Shirran, Roddie Lovett Alpin MacDonald Photos: Alan Kinghorn	7

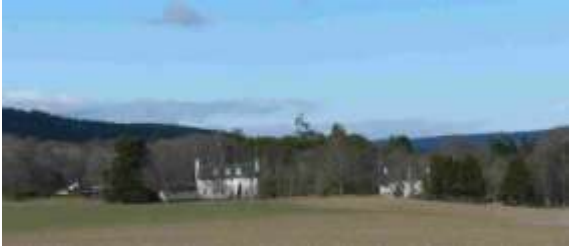
NH 61796 67049	Surviving	Two large houses known locally as the Captain's house and the Commander's House are on Newton Road north, but there is some confusion as to which house is which. They were said to have been built by the military during the wartime expansion in the late 1930s. On the RAF 1946 plan, both are listed as Married Officer's quarters, but they clearly were houses for important officers. The current owner of the northernmost house was told that it was the Captain's house, and was also used as the Officer's Mess. If so, this was presumably only for a short period, until the Officer's Mess in the A camp was completed.			Alan Kinghorn	7

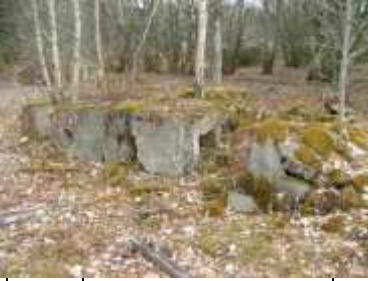
NH 61972 67013.	foundations only except for chimney	The foundations survive of the Officers' Mess, with curved paving leading to three entrances still clearly visible. Like many buildings in the area, it was built over a cavity. Remains of urinals and other plumbing survive, but may date to post-war activity at the site. The cook house was to the south of it. The 1946 RAF plan says it was 'Timber Hutting'. The chimney at the north end still survives (NH 61971 67017), but does not appear on the 1946 aerial photograph, so must be post war. It does appear on the 1965 aerial photograph. Nearby supports for a structure, perhaps a tank, (NH 61969 67025) suggest that this may have been oil fired. Perhaps this was built when the Americans used the airfield in 1955/6. After the war, this complex was used as offices in the 1960s and a Youth Club in the 1970s, and for activities such as snooker and dances. Catriona Fraser remembers going to a dance there in the 1970's. The building burnt down in the mid 1970s when it was still a youth club.			Eddie Szymborski, Willie Fraser, Catriona Fraser, Alec Brett Roddie Lovett Bill Shirran Photos: Adrian Clark and Susan Kruse	7

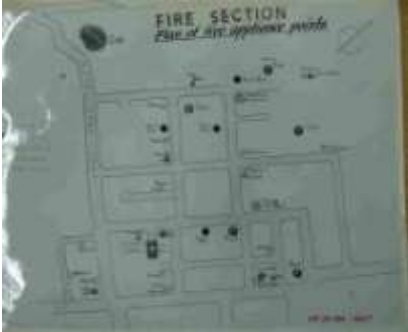
<p>F H 2 FT F.D. BIRD. HYDRAULIC ENGINEER PALMER STREET WESTMINSTER</p> <p>The one to the north has similar detail, but formatted in a different manner on a horizontal plate.</p> <p>The hydrant at NH 62052 66890 has the open well with a pipe within it. A plan from c. 1942 survives of all fire points and apparatus in the A camp (NA AIR 29/594).</p>

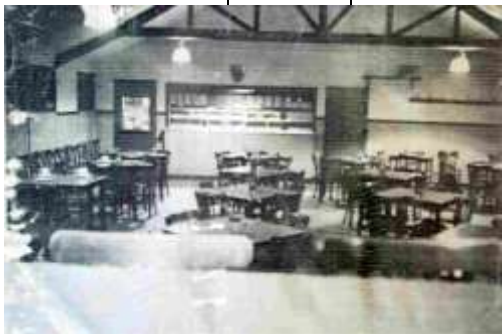
<p>The Mugdoch Hut Canteen was a wooden building named after the people who gifted it for use as a canteen for service personnel. It was still there in 1960s, but was demolished, and the existing Church Hall is on its site. Cathy Gallie remembered that it was a very busy place, used by the convoys heading north and personnel from the RAF and Navy camps. The hut had a stage/platform with a piano, and game's room with a billiard table, table tennis and darts. It could take about a hundred people at a time. Norwegians, Canadians, Newfoundlanders, Poles, Mauritians, French and Indians all attended, and there were even Moslem prayer gatherings. After the war, displaced persons came to the tea room. Cathy Gallie's photos are available (copies with Evanton Oral History Project) and the text of an interview with her is online at http://www.spanglefish.com/evantonoralhistoryproject/index.asp?pageid=472754&msg=Content%20Updated Eleanor Munro remembers that Miss Thomson ran the tea room. She later lived at Arduillie Lodge. Her sister was the companion to Helen Keller, and Helen Keller visited her later.</p>			<p>Catriona Fraser. Interview with Cathy Gallie, collect by Adrian Clark as part of the Evanton Oral History Project</p> <p>Photo: Cathy Gallie, donated to Evanton Oral History Project.</p>	8

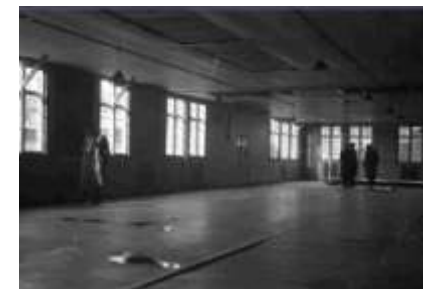
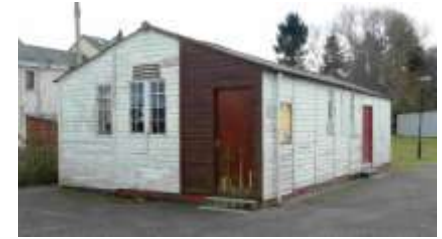
- WW2 wooden huts made of cedar wood, were bought by Gordonstoun. The Gordonstoun archives contain photographs and notes of the site visits before the purchase, and pictures of the buildings erected at Gordonstoun. Many are still in use including the estate offices, classrooms, accommodation buildings and even adapted into the cricket pavilion. Alex Fraser's father was involved in the dismantling. (Photo: © reproduced by permission of Gordonstoun School Archive)
