**Archaeological survey of two possible
Thomas Telford bridges,
A836, between Invershin and Lairg, Sutherland**

Janet Hooper

ARCH
Archaeology for Communities in the Highlands
January 2015

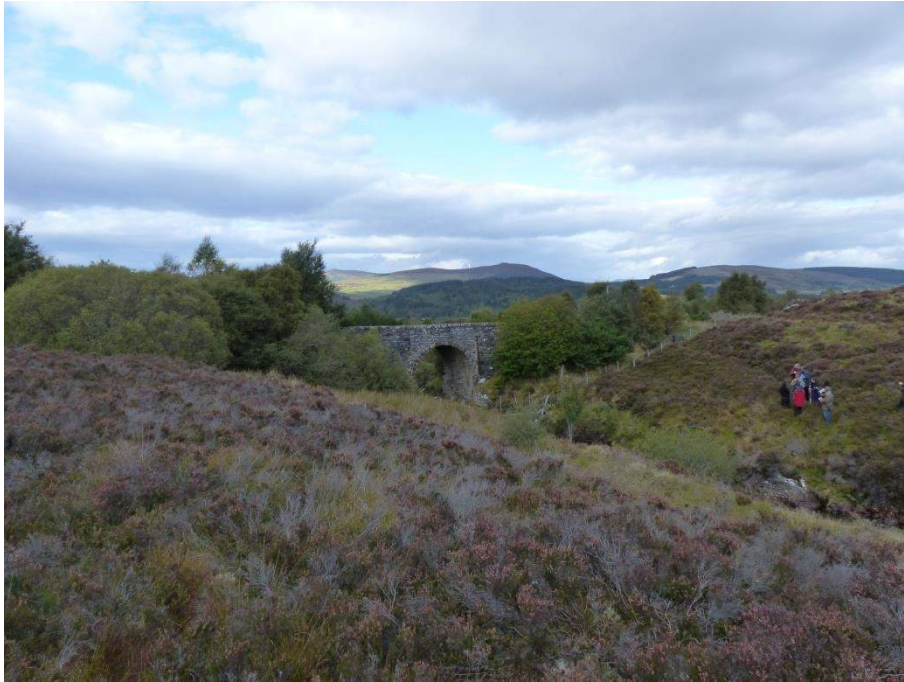
Long view of the bridge. The hollow way on its north side is visible, with the group standing in it (John Wombell)

The bridge over the Allt na Fearna Mor has a slightly splayed approach, though the parapets and roadway are level - and the parapets parallel over the arch. Its battered abutments, approximately 5m long, terminate at vertical spandrels, which mean that the spandrel itself is recessed. All these features ensure that the Allt na Fearna Mor bridge matches Curtis's description of a Telford Type 3 bridge (1981, 489-90). The span of the arch is c. 4.85m wide at the base. The roadway itself is 3.6m (11'8") wide in the centre of the bridge, which equates well with Telford's specification that the 'breadth of the Roadway between the Parapets to be Twelve Feet in the narrowest part' (quoted in Curtis 1981, 488).

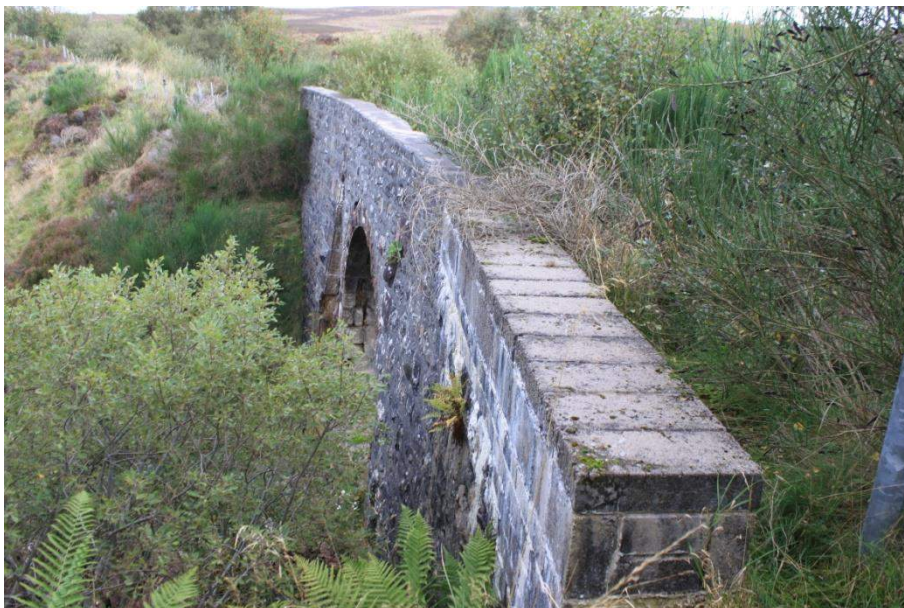
View of bridge along W face, taken from the S, showing curve and profile of spandrel, with the repaired section of parapet in the foreground (Susan Kruse)

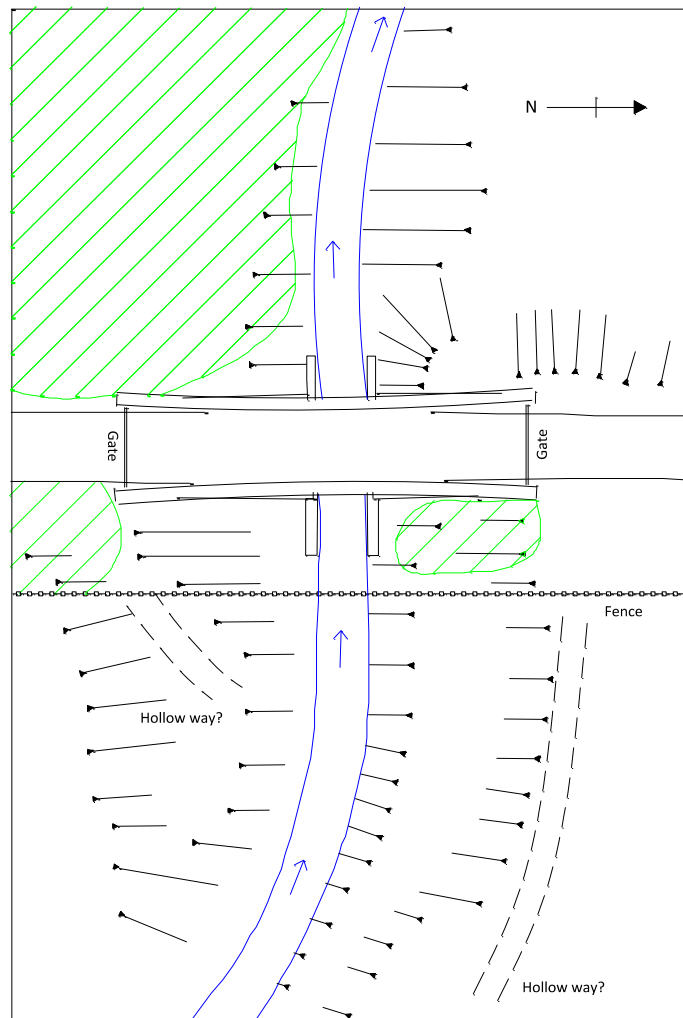
Sketch plan of Allt na Fearna Mor bridge, showing location of possible hollow ways. Areas of trees are hatched in green

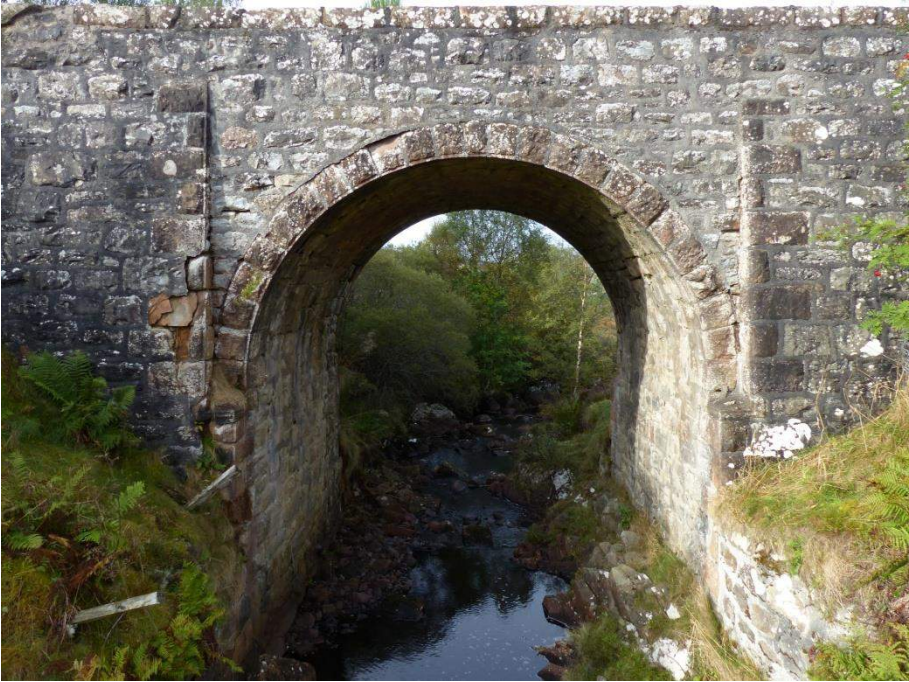
E face of the bridge (John Wombell)

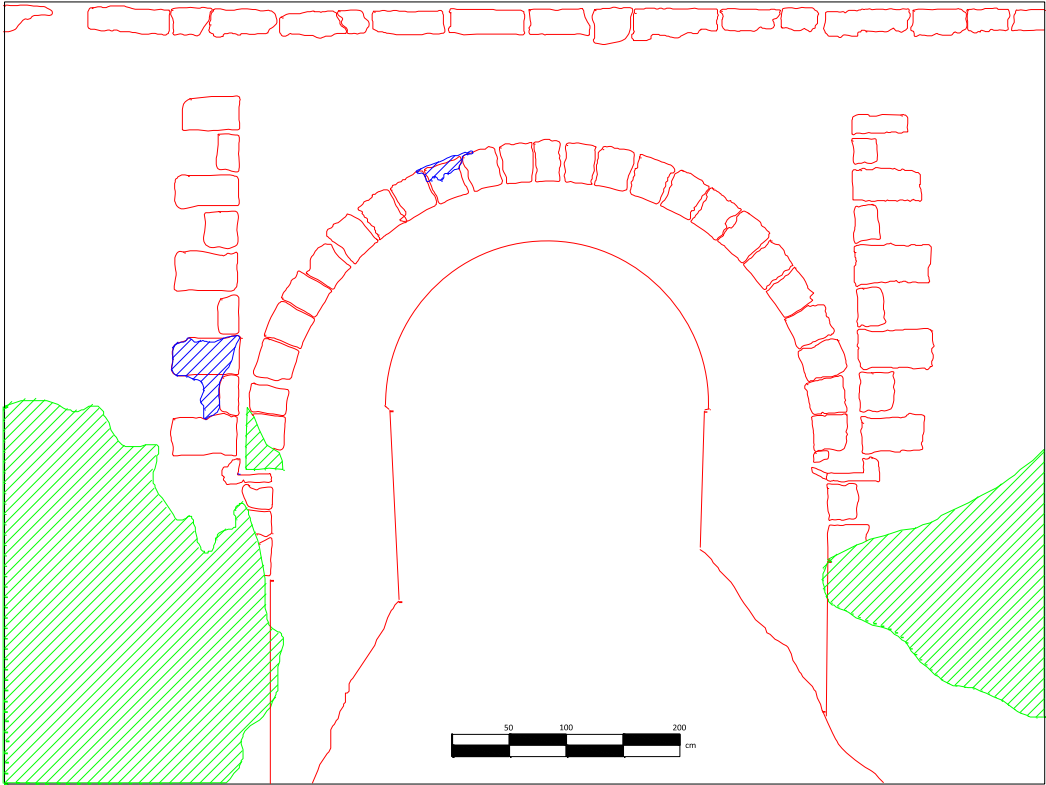
Detail of E face of bridge. Areas obscured by vegetation are hatched in green and weathered areas in blue

The stonework of the bridge is generally intact, but a large area (around 1.2m wide) of severe weathering has removed the facing at the base of the spandrel at the south-west corner of the arch - and some of the red sandstone blocks used to define the arch and recessed spandrels are delaminating, removing the simple rebated moulding which provides their only architectural distinction. Pressure cracks are particularly visible in blocks close to the base of the spandrel on the south-west and south-east sides of the arch. Some damage is clearly very recent - and has been exacerbated by the fierce storm at the end of August 2014. The stonework of the bridge consists of squared blocks of (local) grey stone, laid in regular courses and well faced, though their definition has largely been lost because of much more recent cement pointing. This heavy cement rendering now stands proud of many of the upper edges of the sandstone blocks forming the arch. Underneath the arch, though many of the joints have been washed out, the bridge seems solid.

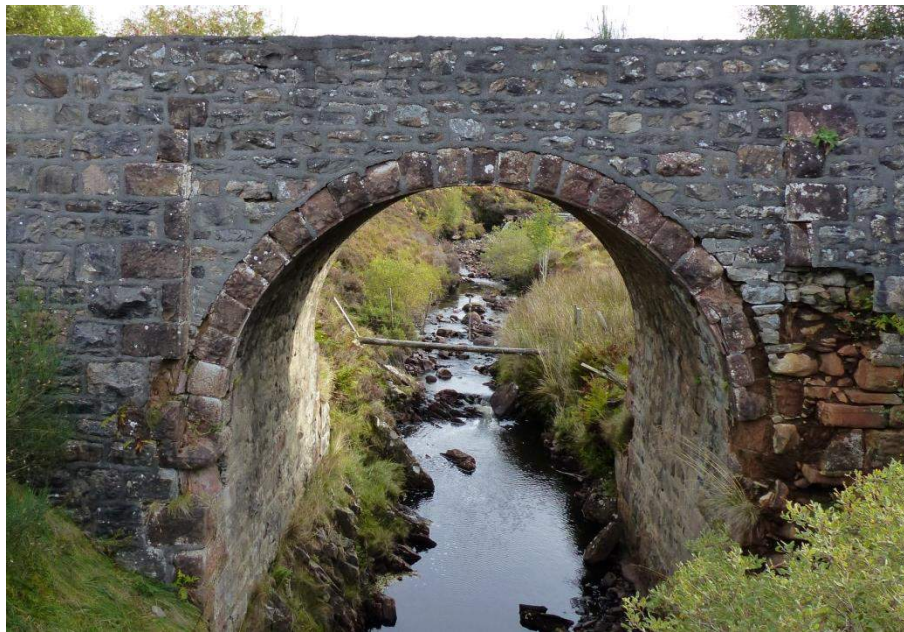
W face of the bridge (John Wombell)

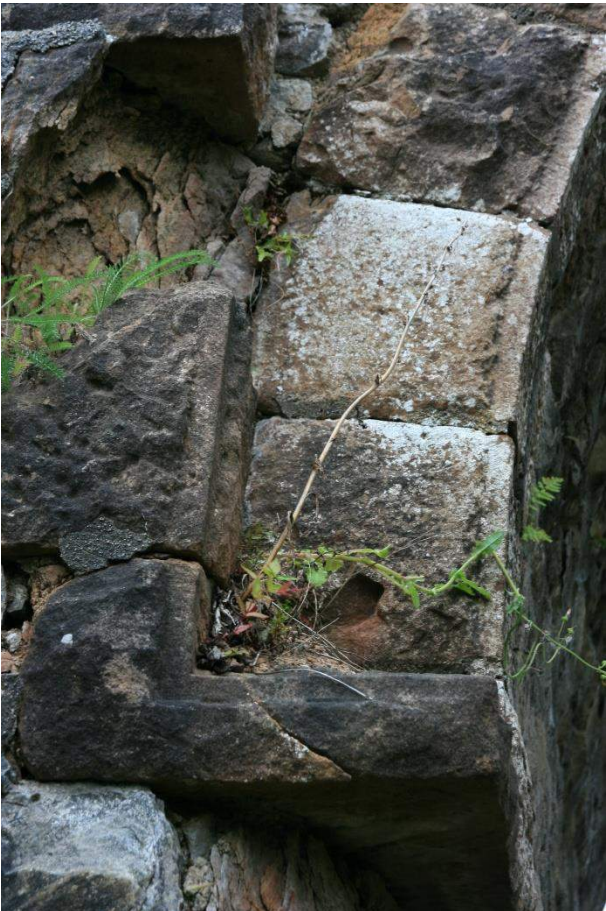
Damage to SW spandrel of bridge (Tom McCourt)

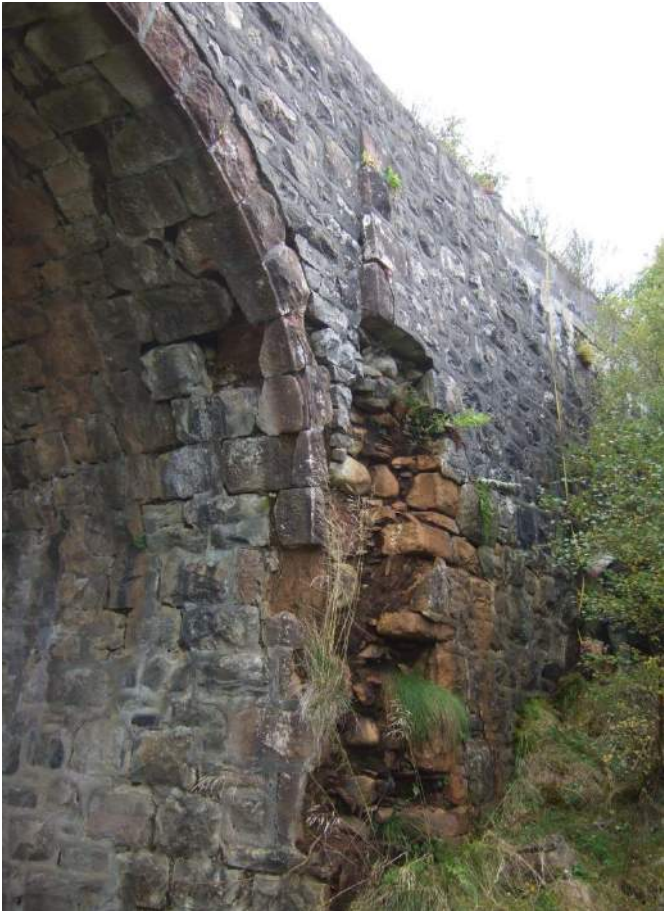
Detail of padstone, with rebated moulding, at base of NW spandrel (Janet Hooper)

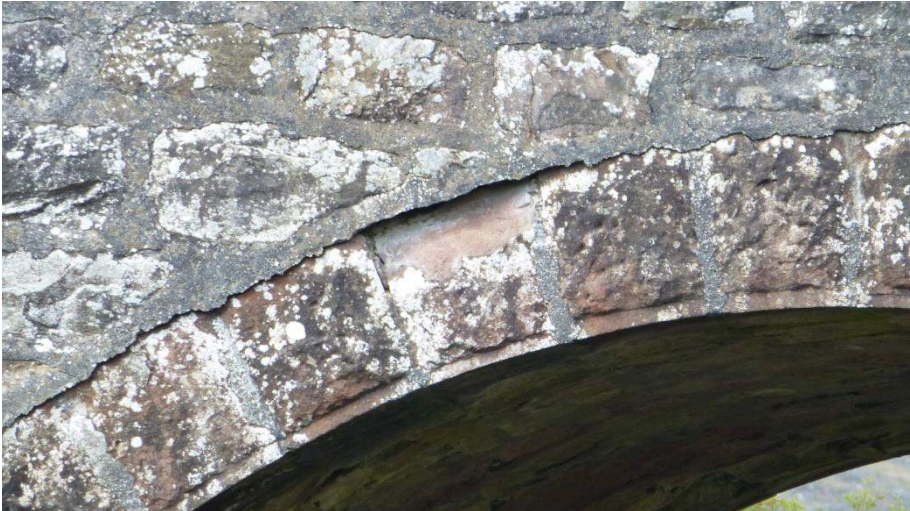
Detail of voussoirs showing impact of cement re-pointing (Jock MacDonald)

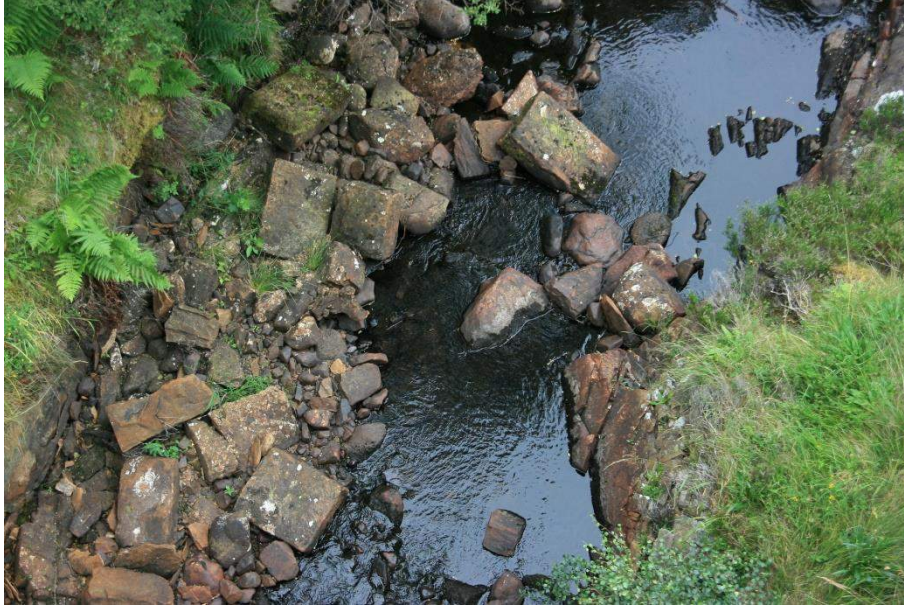
The top of the recessed spandrel is 2-3 courses below the parapet coping, where it survives on the east side of the bridge - but this is also the case on the west side, where the cope stones are clearly visible lying in the burn, confirming that on this side the parapet has been rebuilt. An area of concrete blocks at the south west end of the bridge provides corroboration; the damage apparently occurred around 1990 (Jock MacDonald, pers. comm.). The cope stones on the east side of the bridge average 0.45m deep by 0.30m high, but vary between 0.35m and 0.75m in length. The top of the parapet is 0.72m above present road level; the width of the parapet and of the cope stones again accord with Telford's specification (Curtis 1981, 488). The blocks in the burn on the west side of the bridge, though some have been damaged in the fall, have remarkably similar dimensions.

Dressed red sandstone blocks, which once formed the coping on the west side of the bridge, lying on the bed of the Allt na Fearn Mor (Janet Hooper)

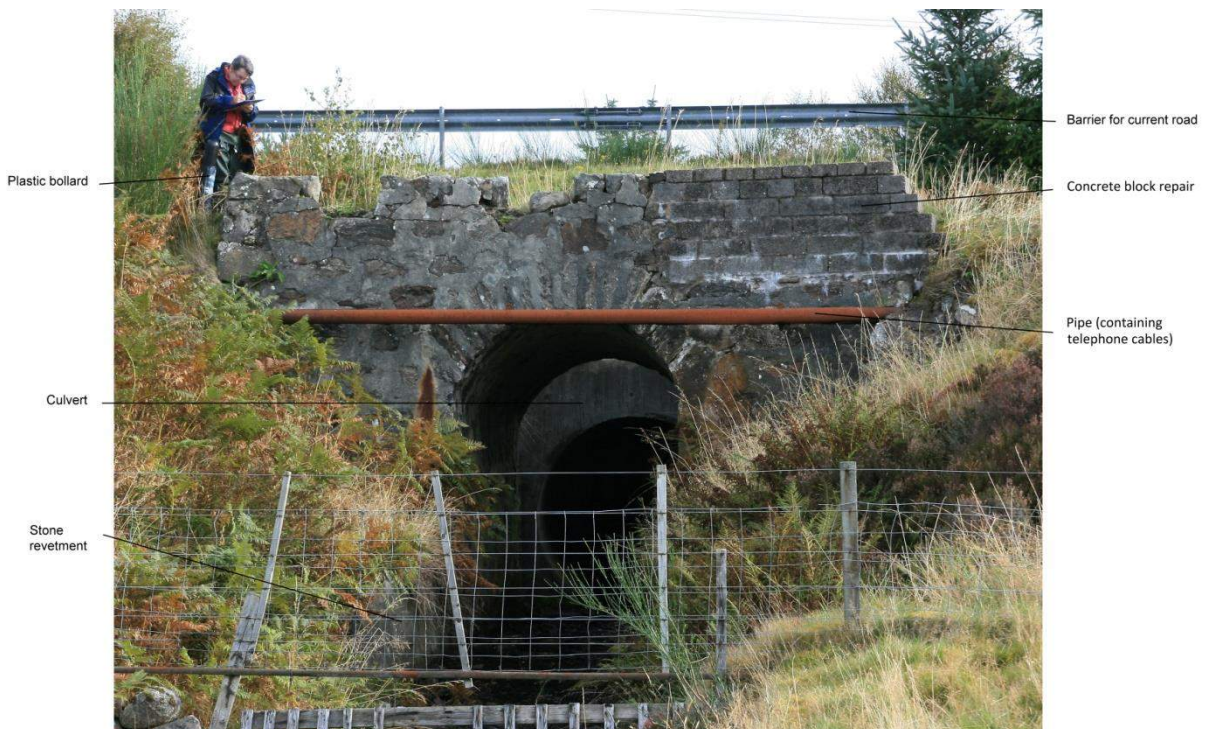
W face of the bridge over the Allt na Fearna Beag (Janet Hooper)

The much smaller bridge over the Allt na Fearn Beag has also suffered the indignity of being slathered in cement. This means it is virtually impossible to see much of the original stonework, though it appears to be similar to that of the larger bridge - however, red sandstone has not been used for the voussoirs or the coping. The bridge does have a slight splay, visible at both ends on the east side, but only present at the southern end on the west side. The faces of the bridge also have a very slight batter. The bridge is 5.25m long, while it is 3.5m wide between the parapets; the latter does mean that the roadway is of similar width to that of the Allt na Fearn Mor bridge and, therefore, also close to Telford's specification.

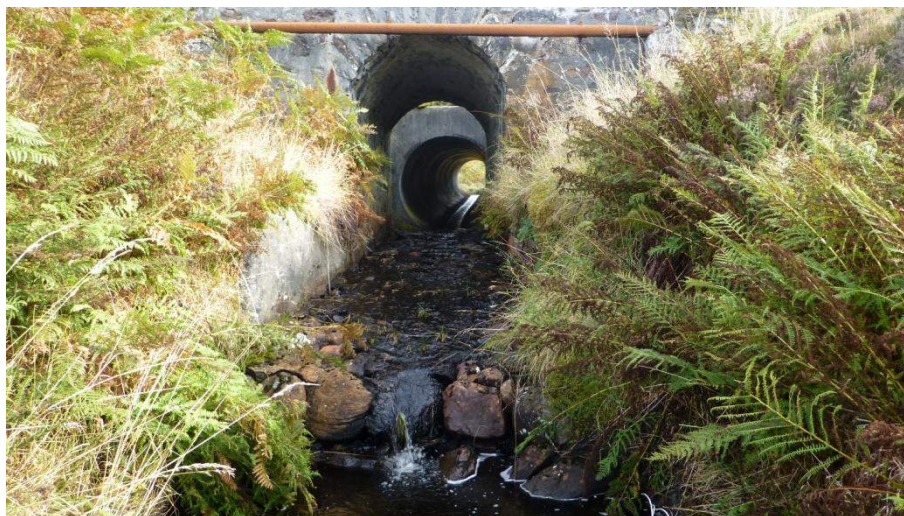
Built up bed of the Allt na Fearna Beag on W side of bridge (Jock MacDonald)

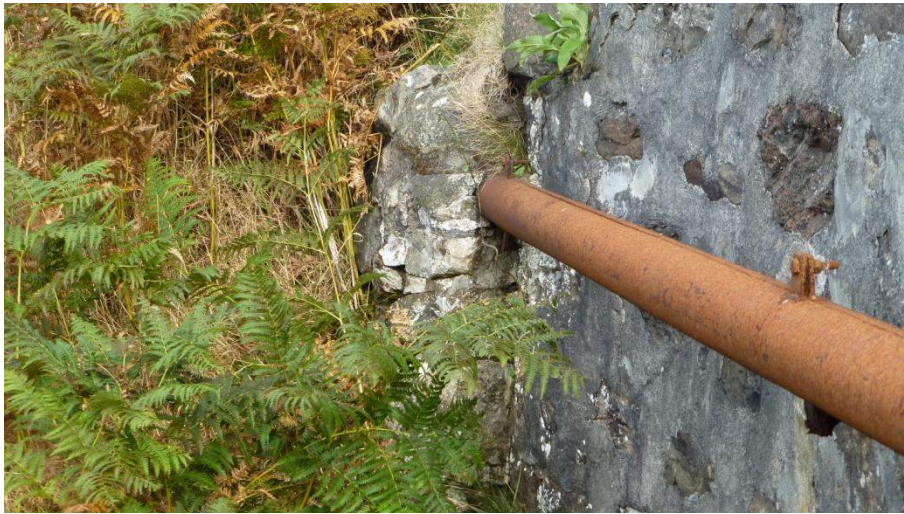
Plastic bollards are still in place along the edge of the roadway. On its west side, two concrete buttresses abutting the bridge support a cast iron pipe carrying two telephone cables (Jock

MacDonald, pers. comm.). Corrosion of the pipe has resulted in staining of the face of the bridge. There are stone built revetments on each side of the burn on this side of the bridge. The bed of the burn has clearly been raised and levelled and a small weir marks the end of the revetments.

Buttress supporting pipe containing telephone cables on west side of bridge (Jock MacDonald)

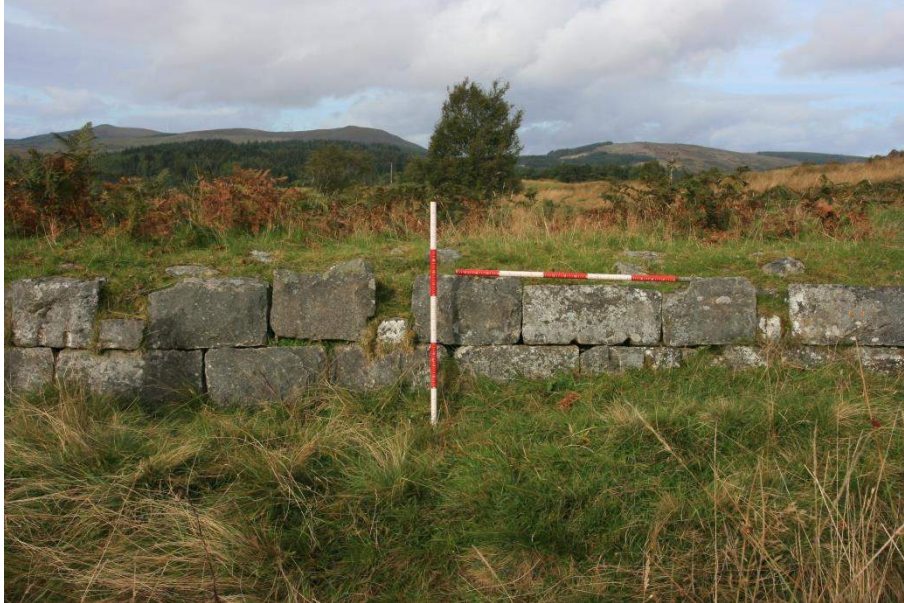
Though only two courses in height (c. 0.75m high), the western half of the revetment is remarkable for the quality of the stonework, the size of the grey stone blocks (avg. 0.5m long by 0.4m high), and the neatness of the joints between the blocks. In the centre of its length, the large blocks of the upper course are separated by smaller stones, but the significance of this is not clear. Several of the blocks have dynamite holes, the presence of which suggests that they must post-date the construction of the railway - perhaps because it was found necessary to control the flow of the burns running down towards it. It appears noteworthy that similar dressed blocks with dynamite holes were used in the construction of the railway bridge over the Allt na Fearna Mor. While its eastern end projects slightly into the burn, confirming it has been truncated, the dressed half of the revetment has a slight curve at its western end, which does imply that it was always intended to terminate at this point.

Dressed stone revetment on N bank of canalised burn (Janet Hooper)

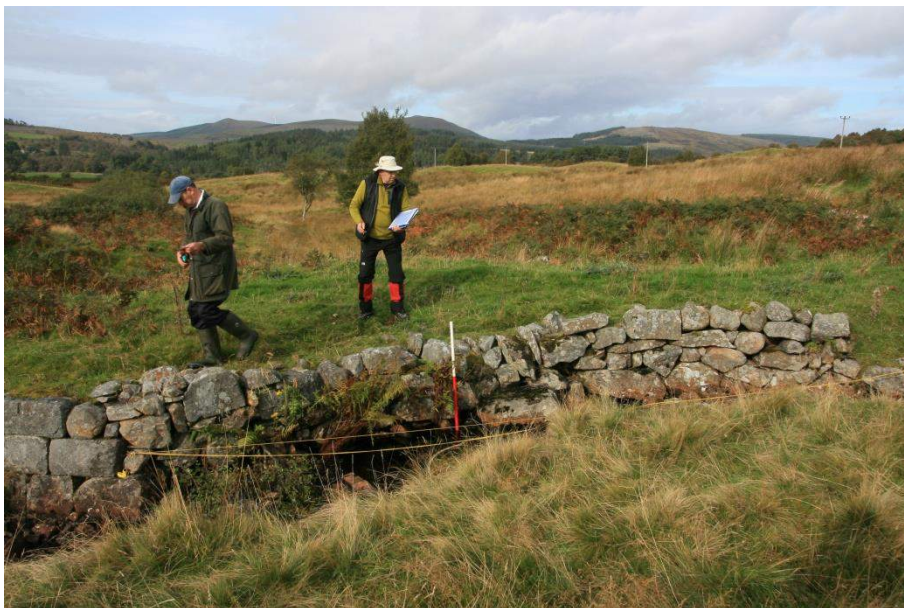
Replacement stone revetment to E of dressed stone section of revetment (Janet Hooper)

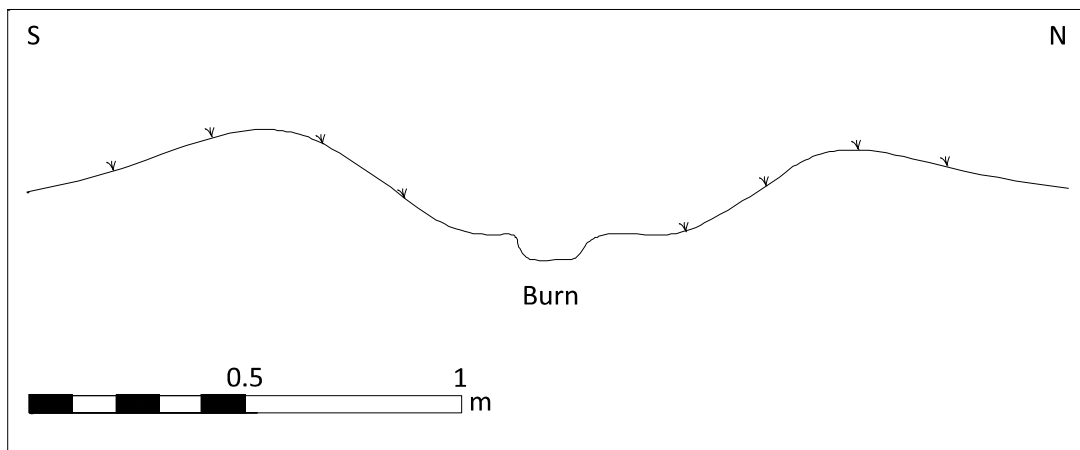
Measured profile across embanked section of Allt na Fearnna Beag

As the burn flows down the slope, it continues between grassy embankments, which are clearly artificial. At the start of the embanked section, is a rough bridge made out of a metal five bar gate and four sleepers (NC 58196 01979), while there is a second bridge, formed from sleepers resting on a large boulder in the bottom of the burn, further to the west (NC 58166 01930). The canalised section of the Allt na Fearna Beag eventually runs into the Allt na Fearna Mor, continuing under a high arched bridge through the railway embankment (NC 58014 01832) to join the River Shin. There is also a substantial culvert under the railway on the original line of the Allt na Fearna Beag (NC 57973 01992).

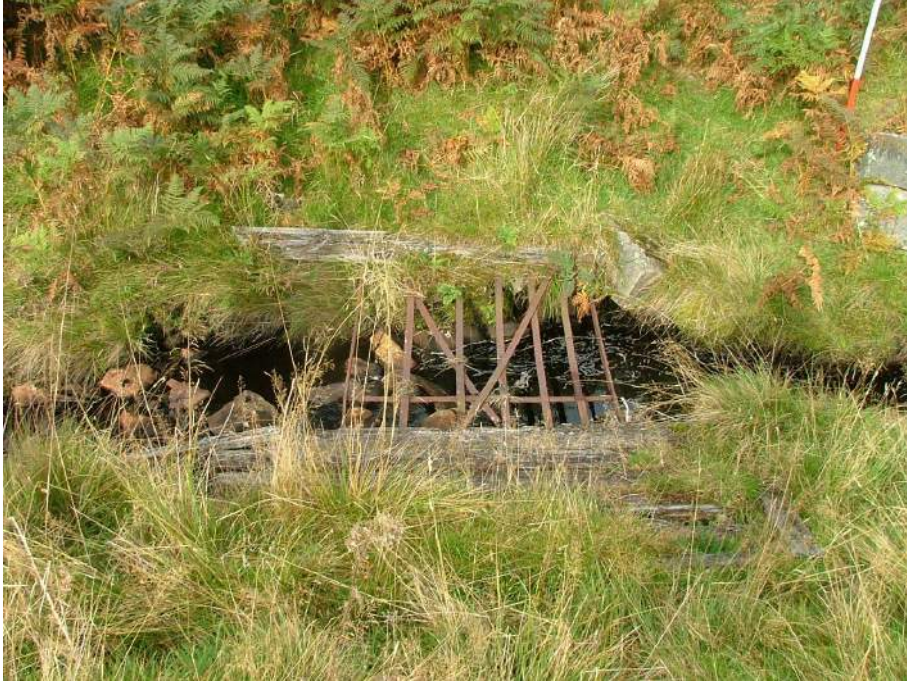
Gate and sleeper bridge at NC 58196 01979 (Mary Stobo)

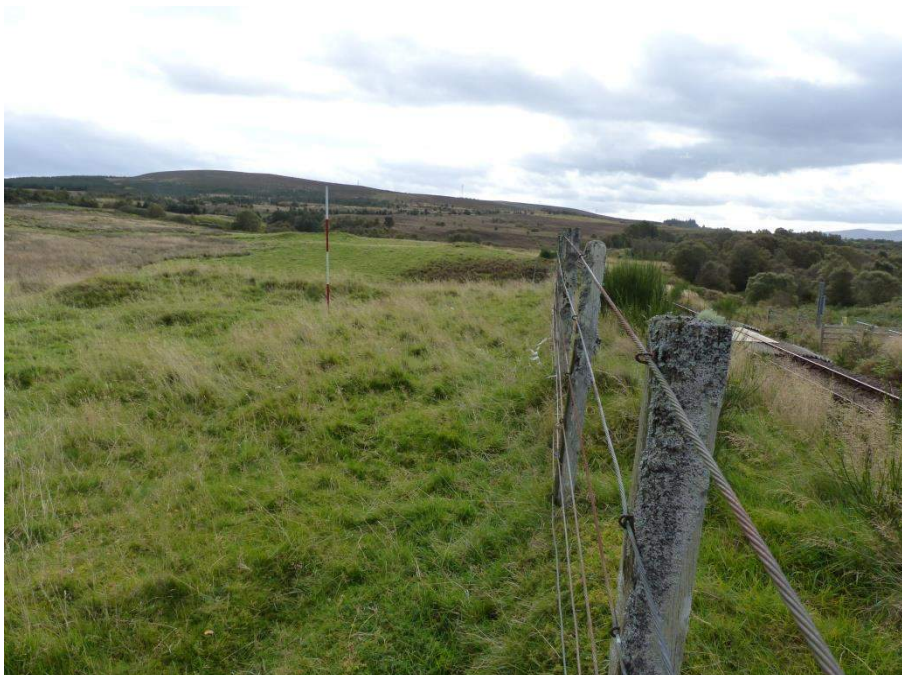
Building centred on NC 58165 01950 JW2

The severely truncated and wasted remains of a sub-rectangular building, measuring 7m NW-SE by 3m NE-SW internally. The building is defined by stone and turf walls standing to about 0.5m high and spread to approximately 3m in width. It appears to have had rounded corners both internally and externally. The building is located on higher ground north of the Allt na Fearna Mor and has been cut across by the fence on the east side of the railway.

Taken from the N
